# Inventory & Schedule of Condition

Reference: RAY211019

123 Sample Street  
Sample City  
Sampleshire  
AB1 2CD

**January  
22nd 2020**

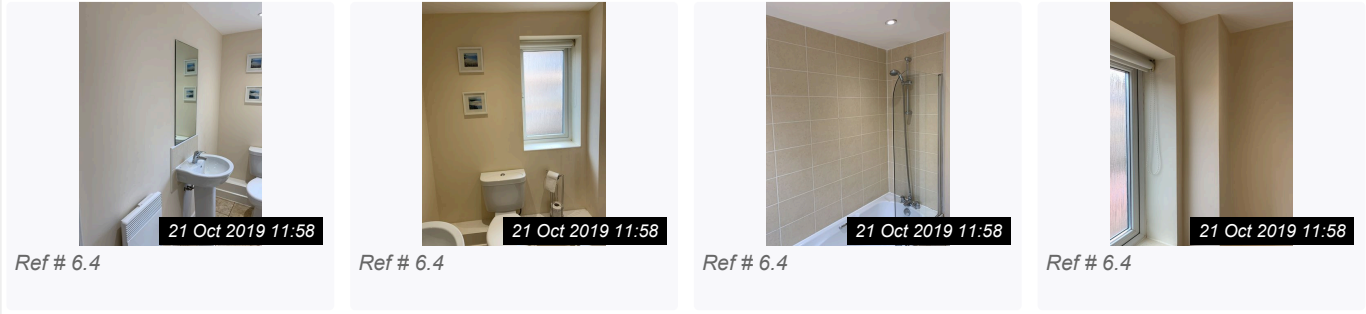
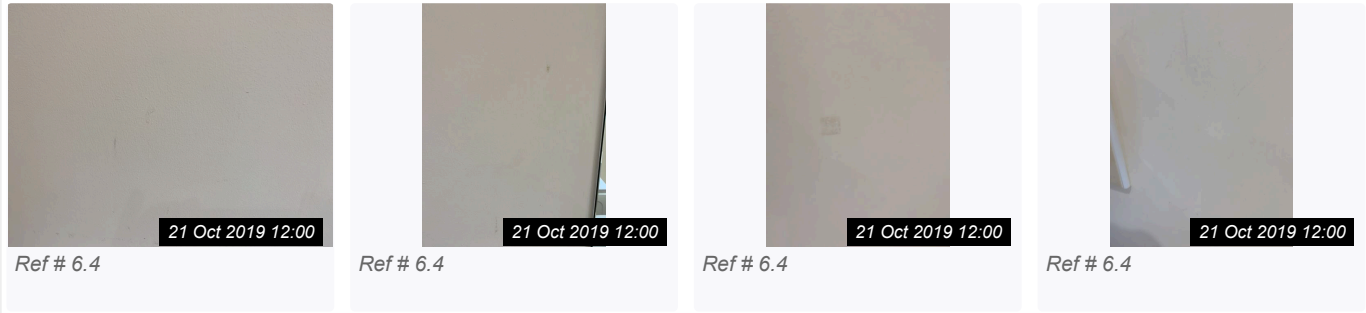
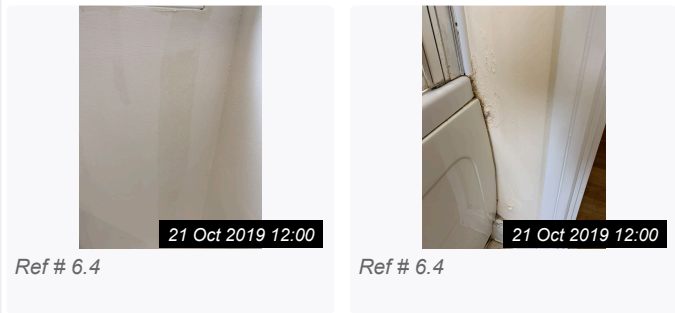
Item	Description	Condition	Tenant Comments
6.1 Door	Brown wooden door	Good condition	
6.2 Ceiling	White painted ceiling	Good condition	
6.3 Lighting	Four spots lights	Good condition	
6.4 Walls	Magnolia painted walls and partly tiled	Few wear marks and rotten wall paint beside the bath as shown in the photos

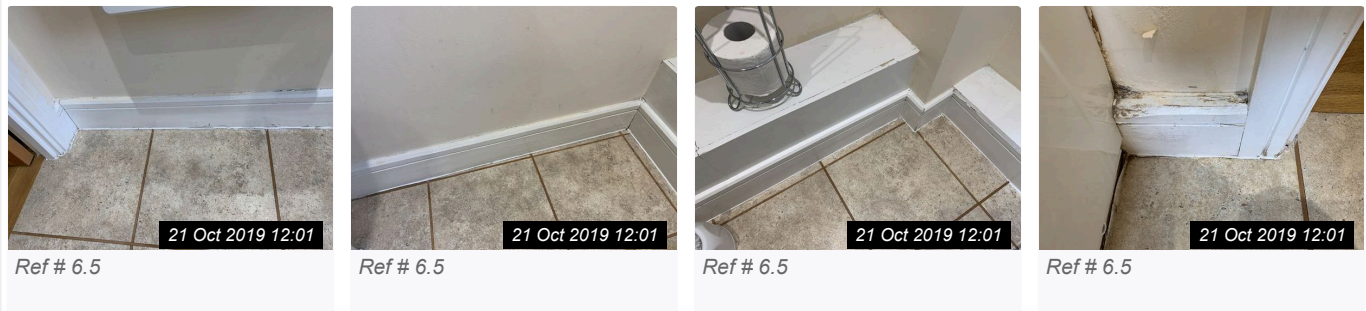
Beside the straight bath skirting is a bit rotten

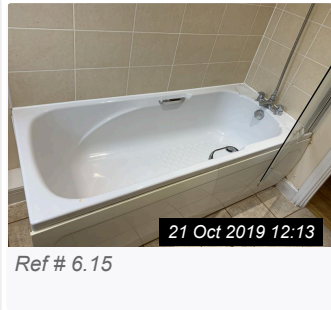
Ref # 6.15

Good condition however there are mould at the back of the tap

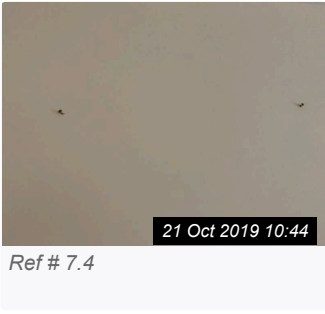
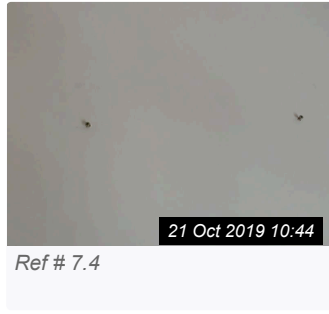
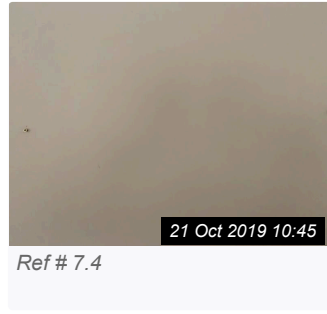
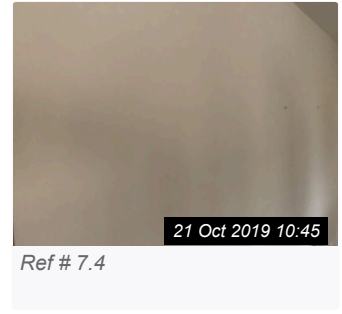
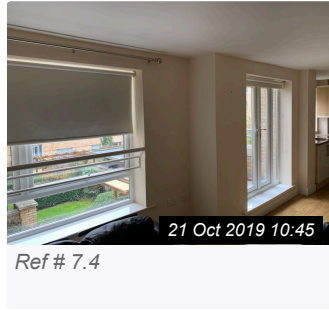
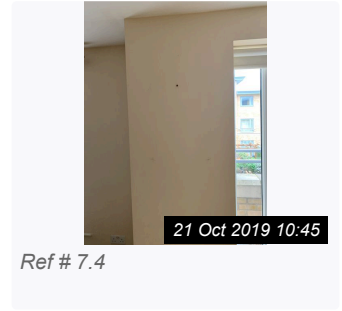
Few wear marks as shown in the photos and 9 Screw holes on the wall

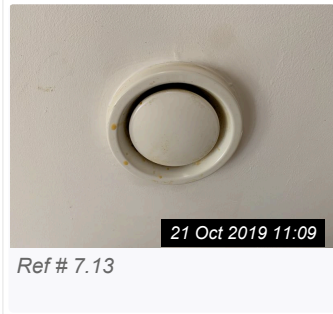
7.13 Extractor Fan	Ceiling extractor fan	Good condition however it appears not clean	
--------------------	-----------------------	---	--

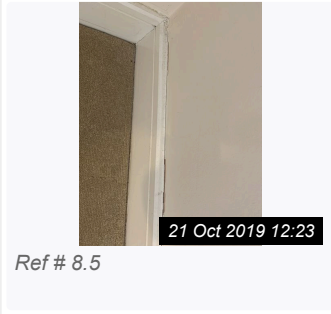
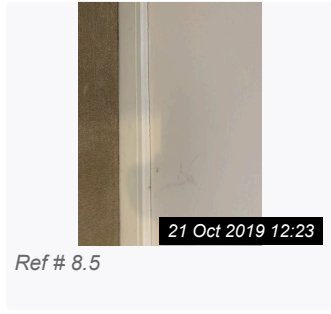
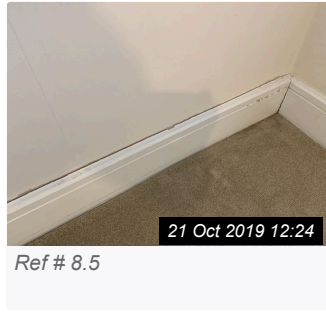
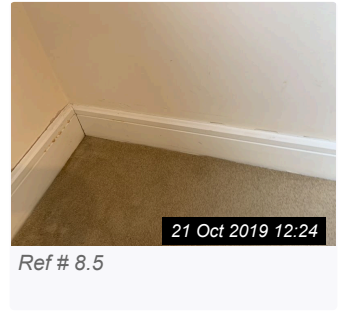
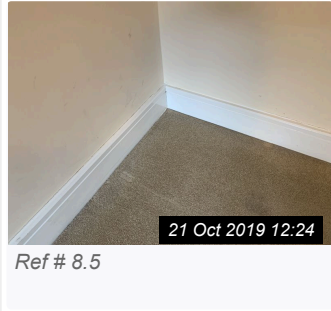
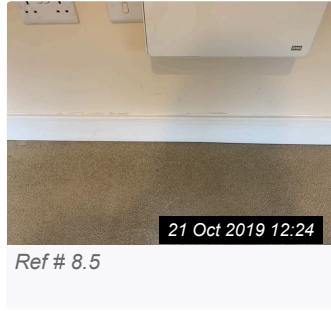
Appears in good condition however there are some few gabs between the skirting and the walls

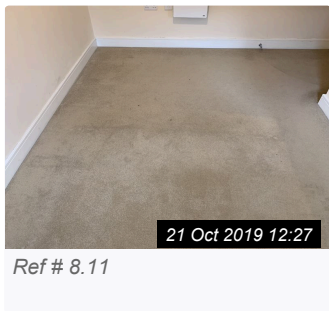
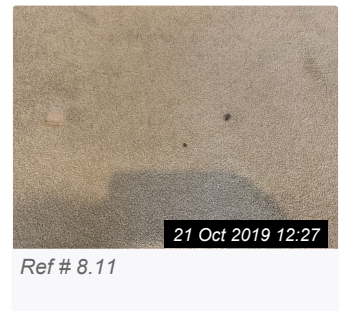
Good condition however few stains on it as shown in the photos

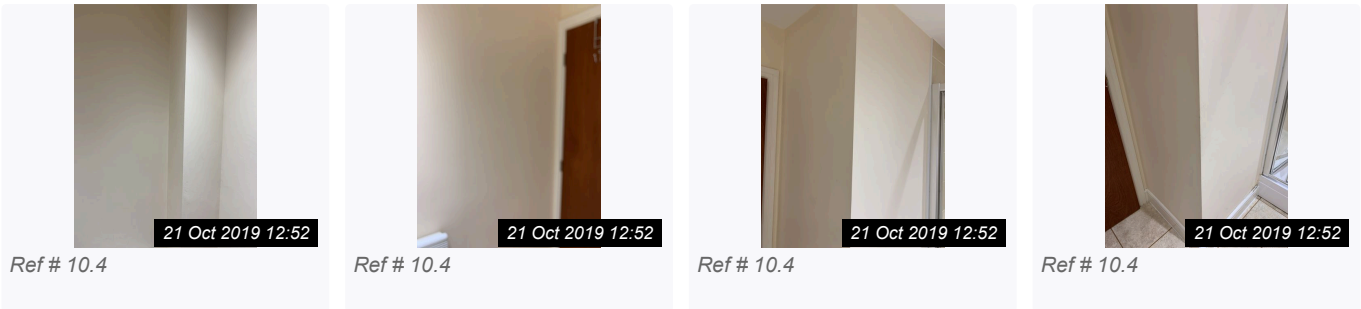
10.4 Walls	Magnolia painted walls and partly cream tiled	Good condition however beside the shower booth the wall paint is rotten

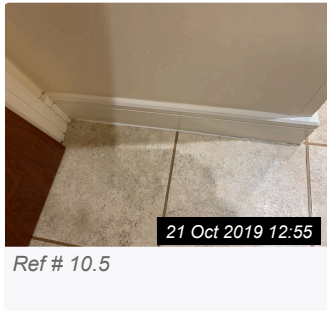
Good condition however beside the shower unit the skirting is a bit rotten
