# Inventory & Schedule of Condition

Reference: RAY211019

123 Sample Street  
Sample City  
Sampleshire  
AB1 2CD

**January  
22nd 2020**

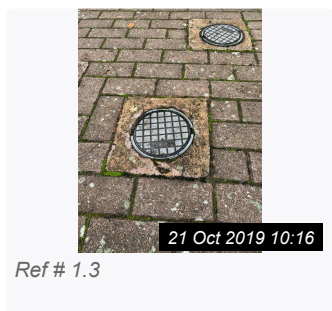
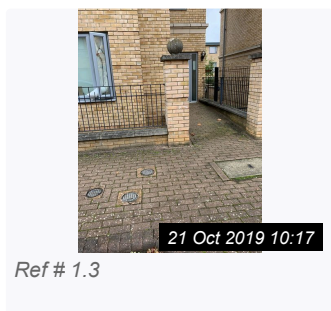
1.3 Water Meter	Location: Outside the main building Serial No: 08M1053274	01312	
-----------------	--	-------	--

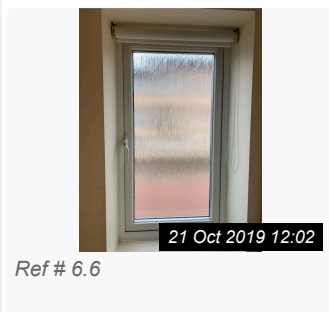
Frosty uPVC double glazed window

Good condition

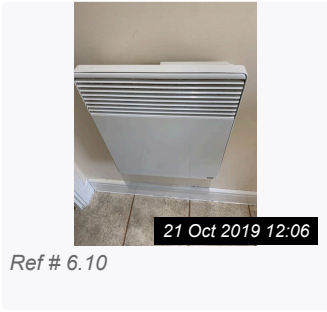
6.10 Heating	Wall mounted electric heating	Appears in good condition

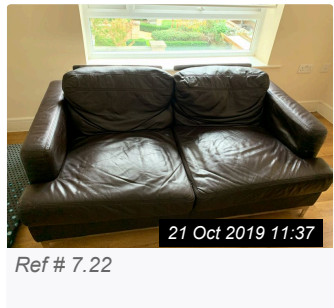
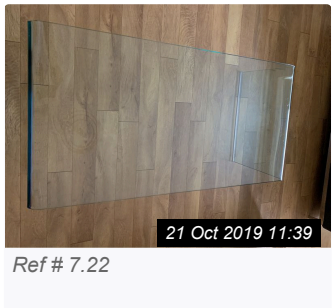
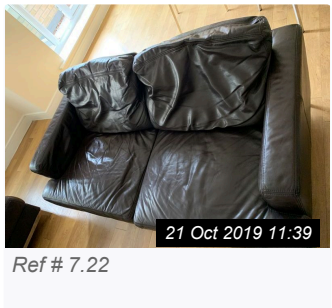
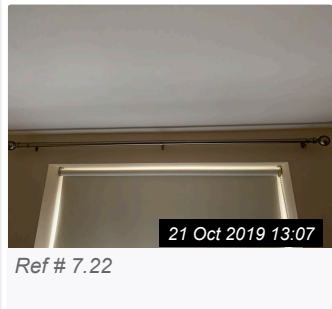
7.22 Additional Items / Information	Two 2in1 brown Leather sofas Dining set 4 chairs and glass table Middle glass coffee table Stainless steel metal curtain pole Lounge ceiling extractor	Appears in good condition	
-------------------------------------	--	---------------------------	--

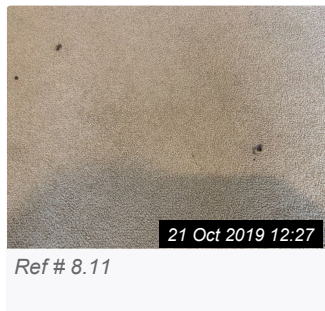
8.11 Flooring

Good condition however few stains on it as shown in the photos
